MOHAWK RIVER WATERSHED  
PECK CREEK BASIN

**PECK LAKE DAM**  
FULTON COUNTY, NEW YORK

**PHASE I INSPECTION REPORT**  
**NATIONAL DAM SAFETY PROGRAM**

Prepared by  
CONVERSE WARD DAVIS DIXON  
CONSULTING ENGINEERS  
91 ROSELAND AVENUE, P.O. BOX 91  
CALDWELL, NEW JERSEY 07006

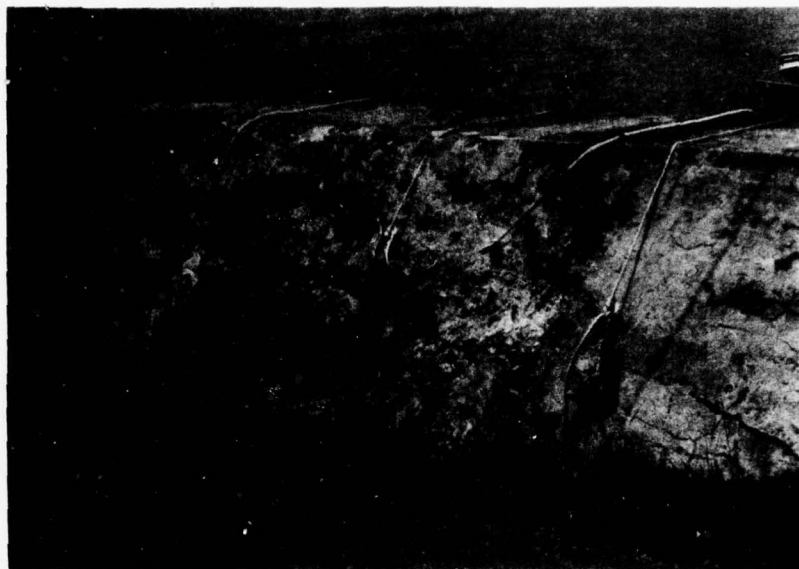
The left gravity wall contains a boat dock (Fig. 1, Appendix D). The soil in the barn just downstream of the gravity wall was wet, but there were no signs of seepage. The downstream slope of the gravity wall is slightly scaled to depth 1/4 to 2 inches (Fig. 2, Appendix D). Some prior guniting was observed on the wall.

FIGURE 1 LEFT GRAVITY WALL (BOAT DOCK)

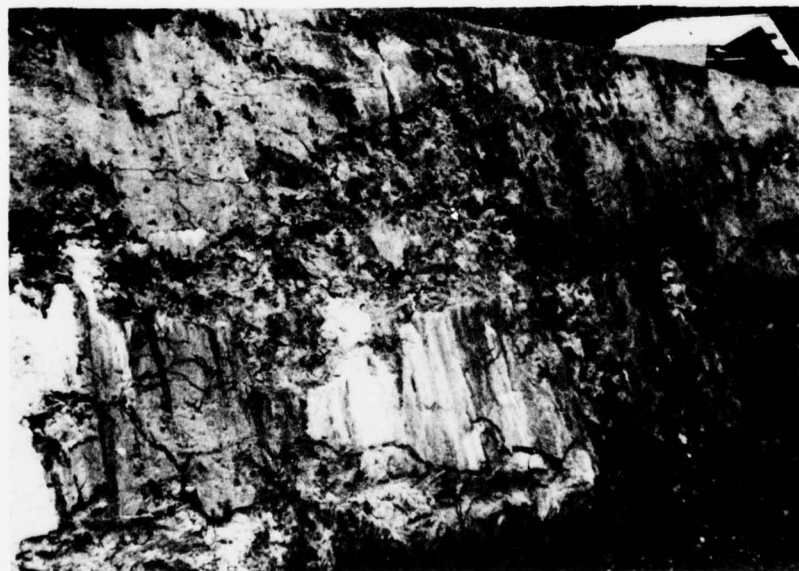
FIGURE 2 DOWNSTREAM SLOPE OF LEFT GRAVITY WALL

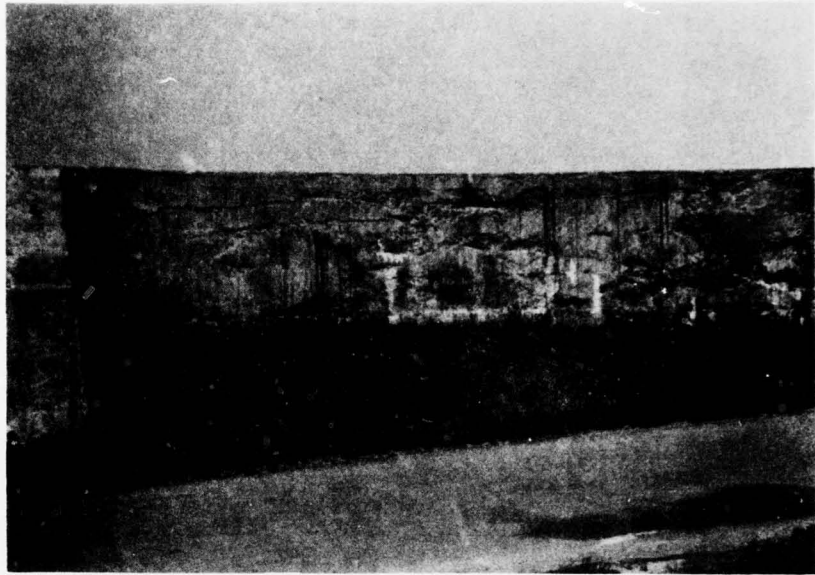
FIGURE 3      BADLY SCALED ARCH 8

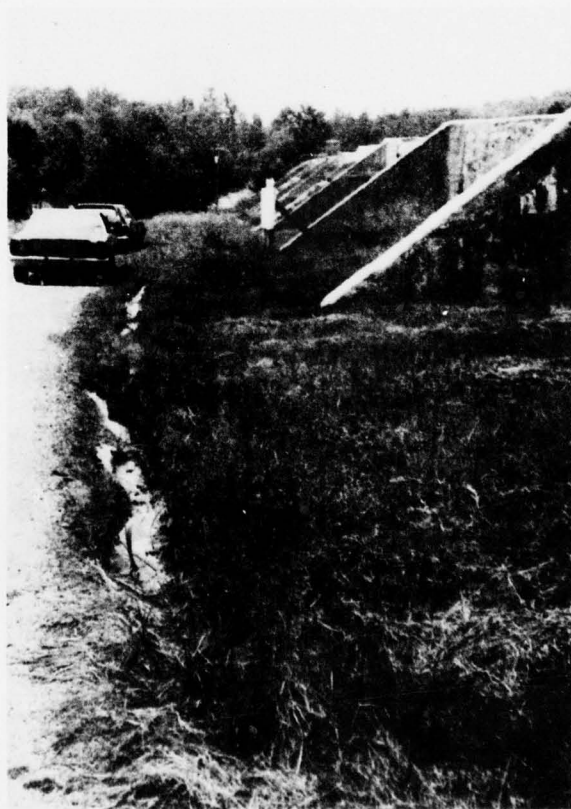
FIGURE 4      SEEPAGE STREAM

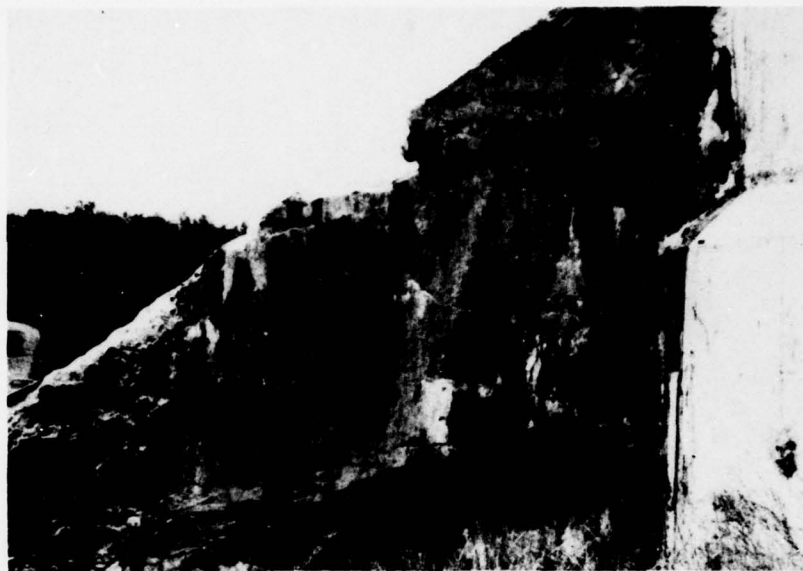
The buttress between Arches 7 and 6 shows the worst deterioration, illustrated by severe cracking and massive spalling (Fig. 5, Appendix D) of the cold joint and a big hole at the bottom, which was wet. Arch 6 has major spalling with one gouge type spall. There was slight seepage high on the wall. The buttress between Arches 6 and 5 is badly scaled. On the right side of the buttress, at the arch, there was a hole in the ground covered with stones. We could not determine if it was an abandoned animal burrow, or the beginning of piping, or something else. Major scaling and spalling was noticed in Arch 5. Some seepage was taking place about halfway up the wall and along the base for about half the arch length. Minor leakage was also observed in areas that had been previously injection-grouted.

FIGURE 5 BUTTRESS BETWEEN ARCHES 7 AND 6

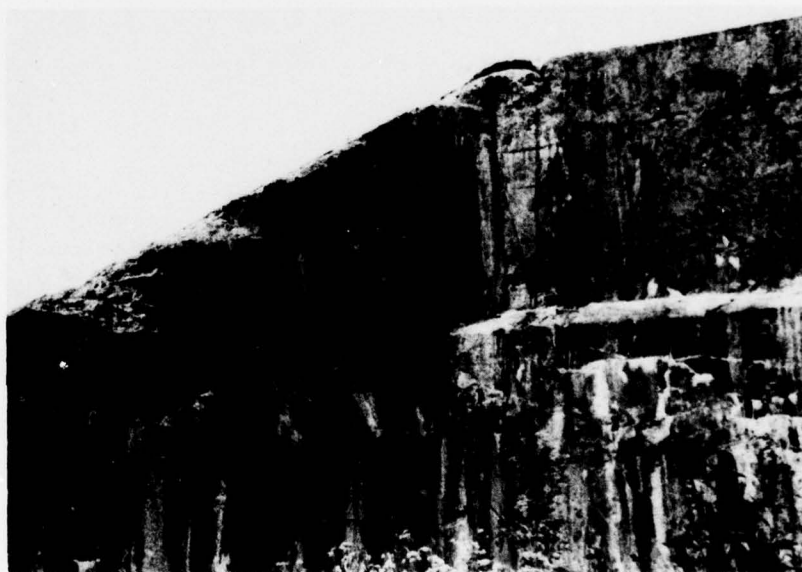
The buttress wall between Arches 4 and 3 is moderately scaled and has a large spall about 3/4 of the way up the wall near its junction with Arch 4 (Fig. 6, Appendix D). Another large spall was also noticed at the base of this buttress wall along a construction joint crack. Near the top, Arch 3 is spalled over its entire length (Fig. 7, Appendix D). The buttress between Arch 1 and Arch 2 is severely spalled and scaled. Some seepage was visible at the joint between the buttress and Arch 2.

FIGURE 6 BUTTRESS BETWEEN ARCHES 4 AND 3

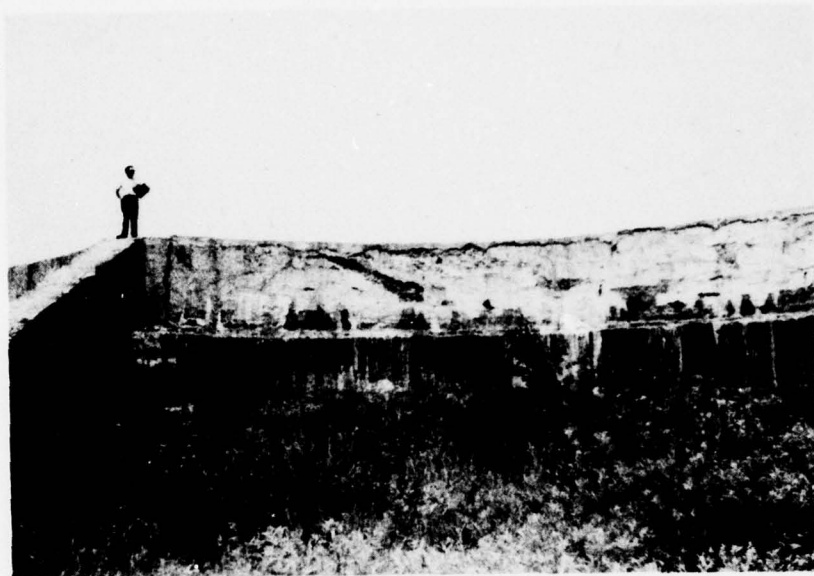
FIGURE 7    ARCH NO. 3

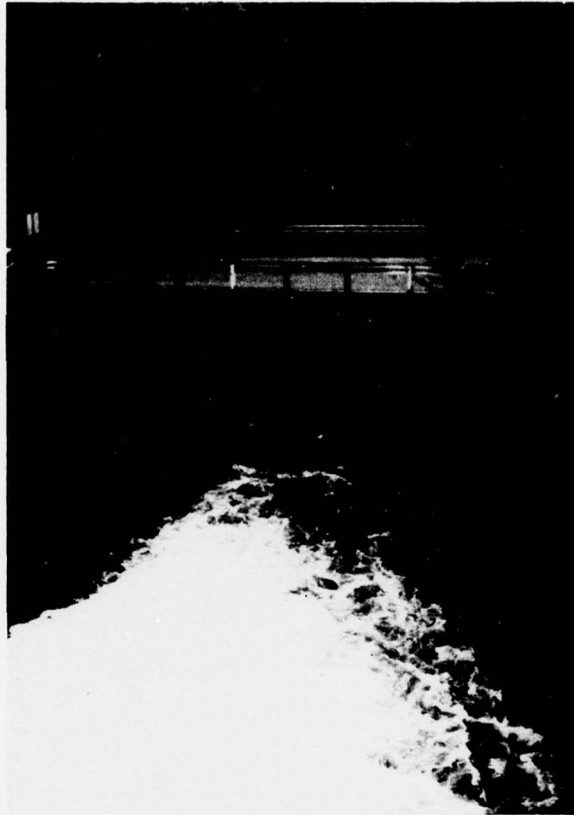
FIGURE 9      DOWNSTREAM CHANNEL

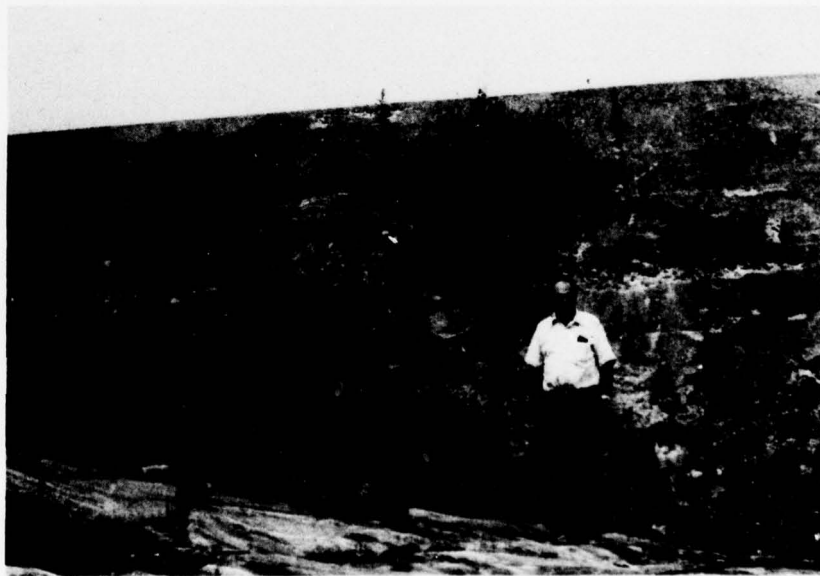
FIGURE 10      GRAVITY SPILLWAY DOWNSTREAM SLOPE

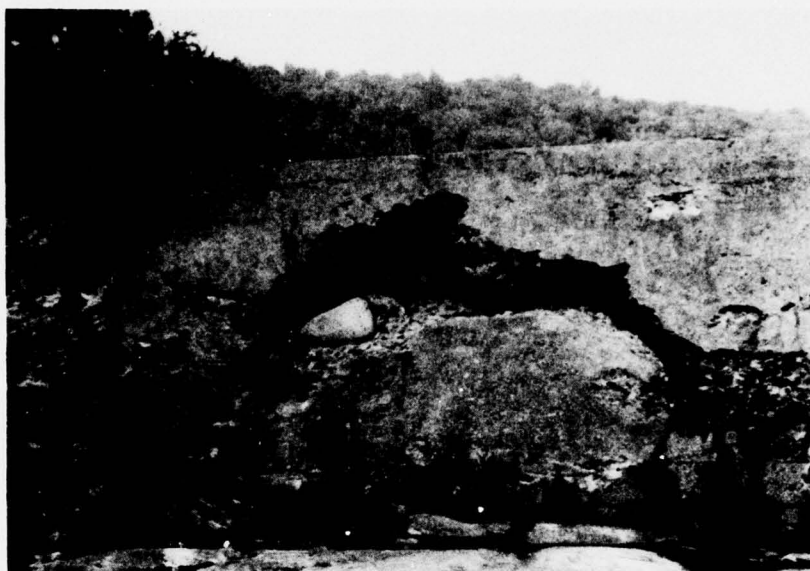
FIGURE 11 GRAVITY SPILLWAY DOWNSTREAM SLOPE

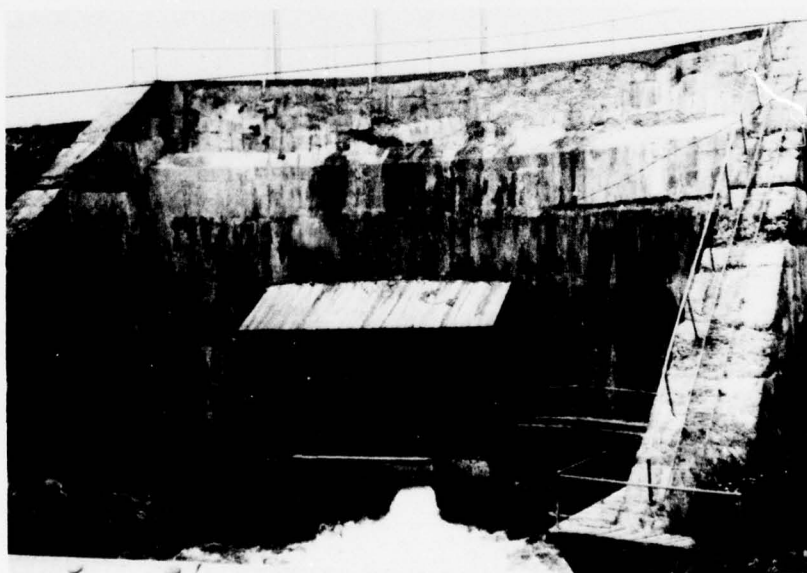
The gate house is located in Arch 1 (Fig. 12, Appendix D). The gate house is a wood frame structure which appears to be founded on rock, but this could not be confirmed. Access to the gate house is through a boardwalk leading from the roadway. In the gate house, there are two manually-operated gate valves, one over each of the two 36-inch diameter outlet pipes. At the time of the inspection, the left gate was open about 10 inches and the right gate completely closed (with water trickling from it). For the sake of inspection, the left gate was opened and the right kept closed. Then, the left gate was shut and the right opened. Both of the gates functioned smoothly with great ease. The tailwater was initially about 2 inches below the pipe invert, but it fluctuated when the gates were opened, and the water level rose to about 2 inches above the pipe invert.

FIGURE 12 THE GATE HOUSE

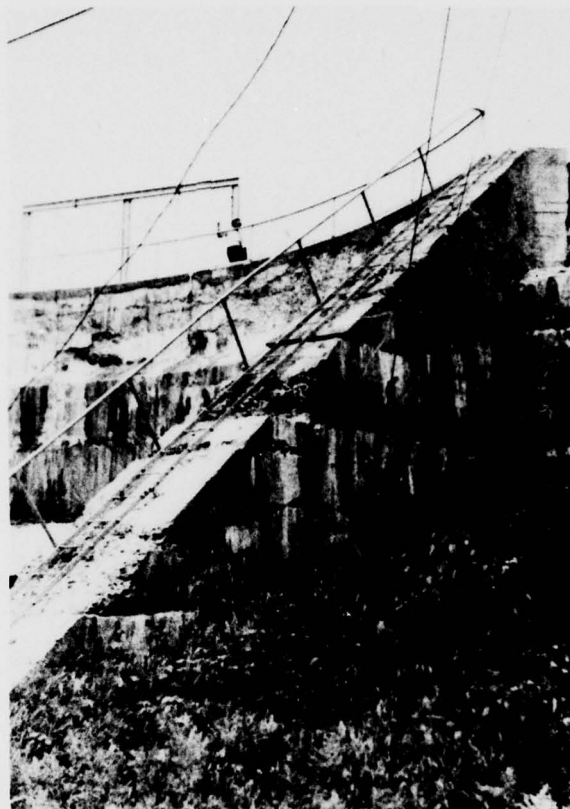
(Figs. 12 and 13, Appendix D). The pipe railing, the steel frame, and the intake structure in general (Fig. 14, Appendix D) appeared to be in good condition. Chains for emergency closure flap valves appeared to be well maintained, but the system was not actuated during the inspection.

FIGURE 13      ACCESS LADDER TO THE INTAKE STRUCTURE

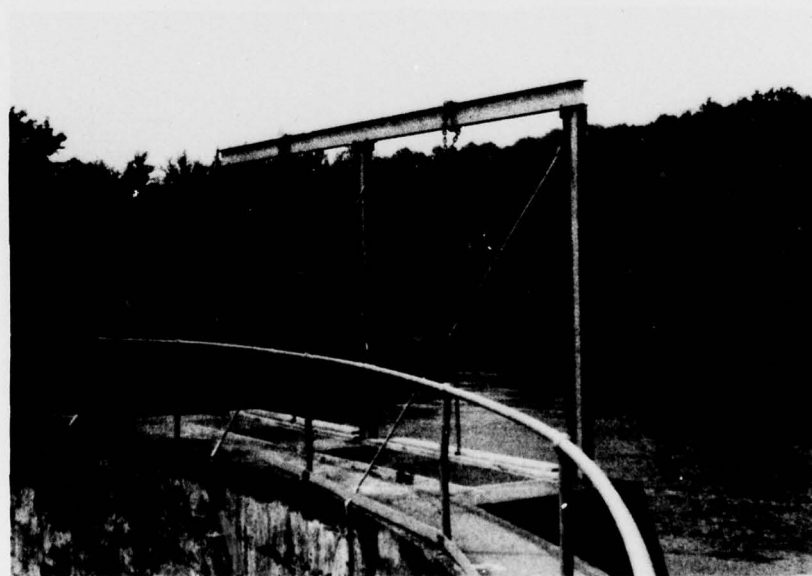
FIGURE 14      INTAKE STRUCTURE

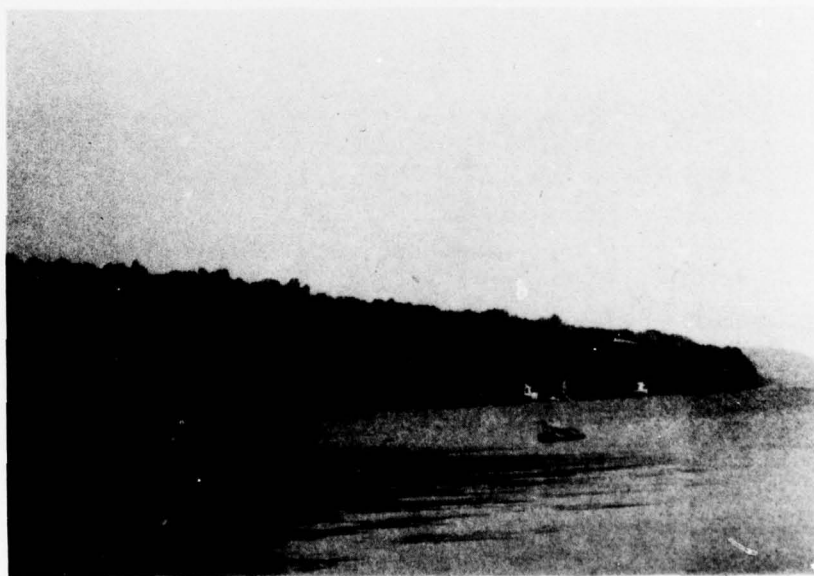
FIGURE 16      RESERVOIR RIGHT SLOPE

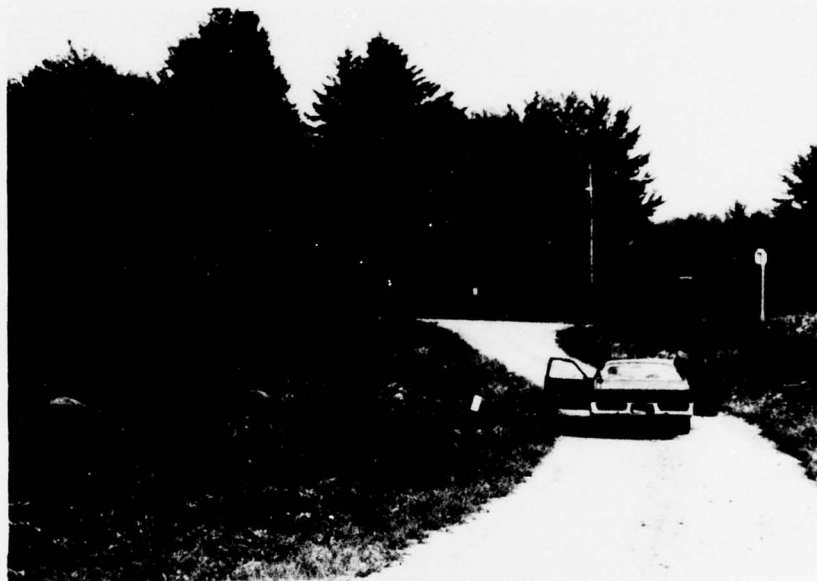
The side slope is flatter along the bay that extends to the right of the dam. The roadway and grade surrounding the bay were checked (Fig. 17, Appendix D) and found to be at least 5 feet above the lake water level, which was 4'2" below the top of the dam on that day. Therefore, the roadway and the surrounding grade are higher than the top of the dam.

FIGURE 17      ROADWAY ALONG THE BAY
